## Tree warden notes on planning application (outline) for Japonica Cottage

The application for outline permission for a house with parking spaces and turning area has a number of problems.

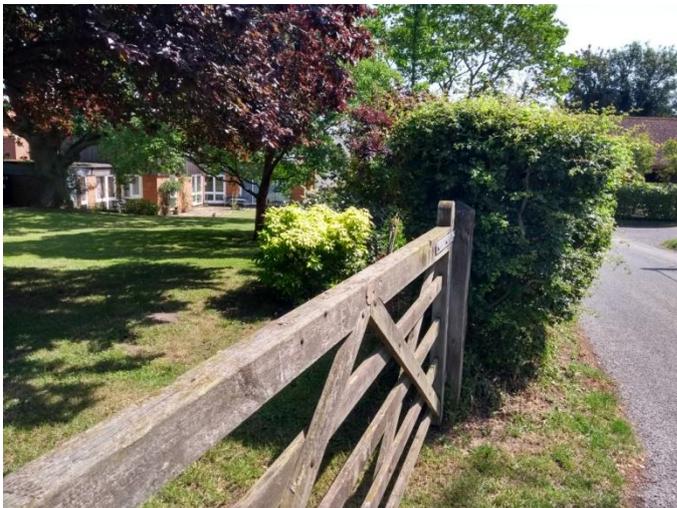
The visibility splay shown here involves the removal of all of the good hawthorn hedge fronting the road which is about a 12m length. Cliff Road leading to the river is part of the character of the village with hedges either side although unfortunately some have been replaced with fencing.

As well as the long stretch of hedge down to where it meets a wall, a piece between the proposed entrance and Dormers next door would also be removed.

Present gateway with hawthorn hedge

If everyone had this sort of visibility splay there would be no hedges – or fences – in the village! There is a 20mph limit. Perhaps a mirror would be possible?

The removal of the proposed length of hedge is unfortunate although more hedge could be planted behind the line.

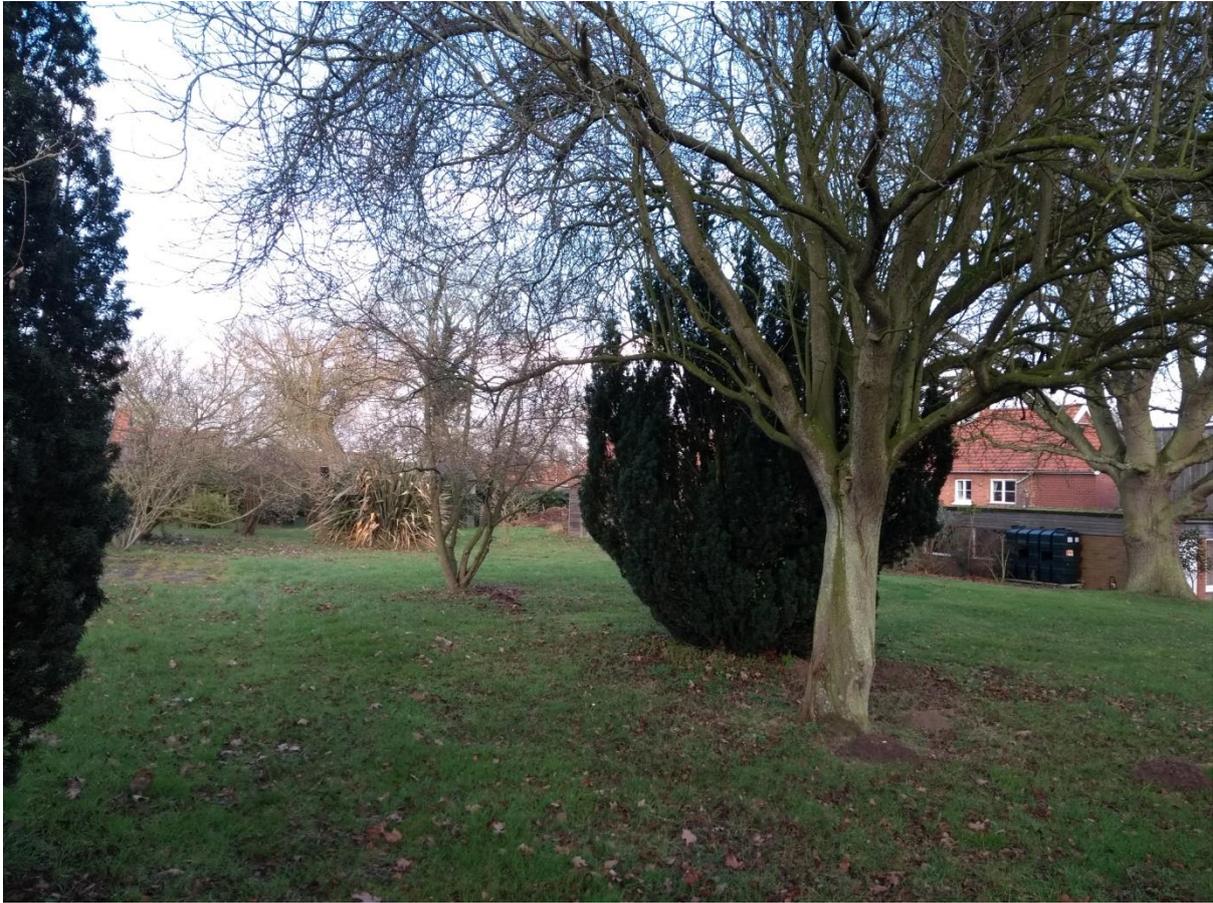
Although the tree report has identified what the arboriculturalist thinks are important trees there are several not named on the plan. In particular this garden is characterised by some impressive Irish Yew trees one near the gate close to the red leafed cherry.

It is unfortunate that both this and the yew to the left (west) of the entrance are to be removed along with several others.

The red leafed cherry although defective (C category) would be expected to be a feature for another 15 years probably as they are tough old things.

The yews are especially important in winter.

Yew tree from the gateway with cherry T3 in front of it (winter). Yew on left is close to laburnum tree T4.

Oak tree T1 is on the far right.

Altogether it is a pity that so many attractive trees are down for removal. I would ask if more care could be taken to arrange matters so that parking and house building are fitted between the trees as a priority.
