Proposed work to TPO trees: Tree Warden's comments

Ref. No: DC/20/4516/TPO

[Lime T2 - to remove two lowest branches, one over sailing club, one on opposite side to balance tree, smaller branches over sailing club, reduce by half, crown lift to first major fork, all to reduce overshading. Oak in W2 - remove two lowest branches and major deadwood, to reduce risk to path and hut users below. - Waldringfield Sailing Club Cliff Road Waldringfield Suffolk IP12 4QL](#)

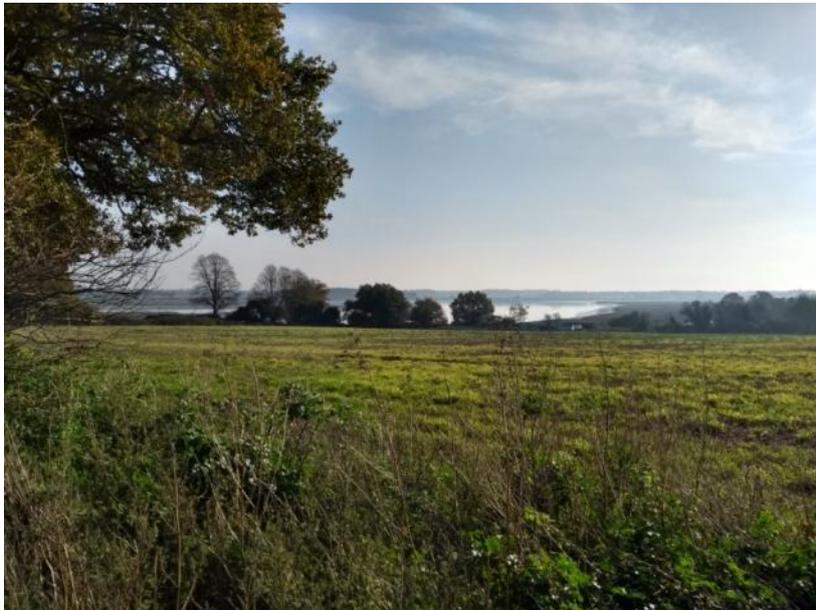
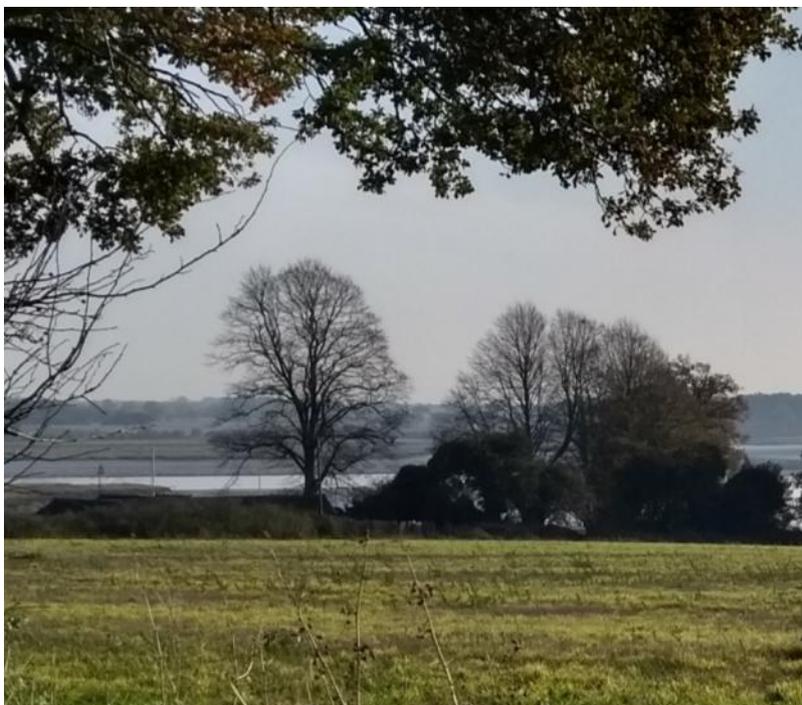
View 1 from footpath

As View 1 above, enlarged: view from the much used footpath towards the river

The Lime or Linden tree T2 is similar in shape to other domed trees seen here on the right of it. Lime trees often have sprouts from the trunk as this one does.

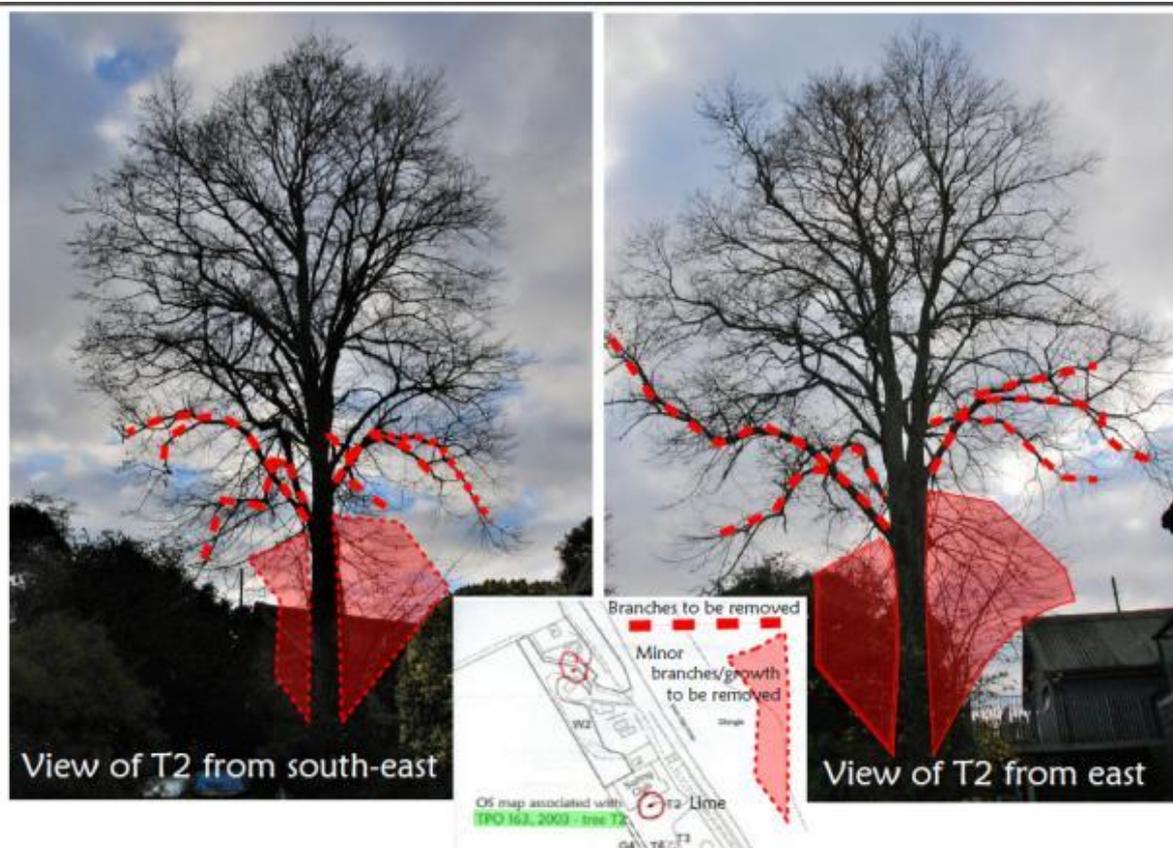
Drawings from the applicant's submission for reference

The proposal is to remove several lower branches and the reason given is 'to reduce overshadowing'. This presumably refers to shading of part of the grounds of the sailing club, ie a paved area leading from the front to the side and rear of the building.

I would make the following observation: The present domed shape of the tree will be spoilt by this operation. The long bare expanse of trunk which would be exposed as illustrated by the applicant above is a different form from other bushy trees along the shore which are all protected by the TPO. The proposal to make the tree more of a 'lollipop' shape is not sympathetic to the overall look of the landscape setting either from close up or from distant views as mentioned in the TPO Statement.

Shortening of the remaining branches is also proposed which would also be detrimental to the appearance of the tree and can lead to 'shaving brush' type growth from the branch ends..

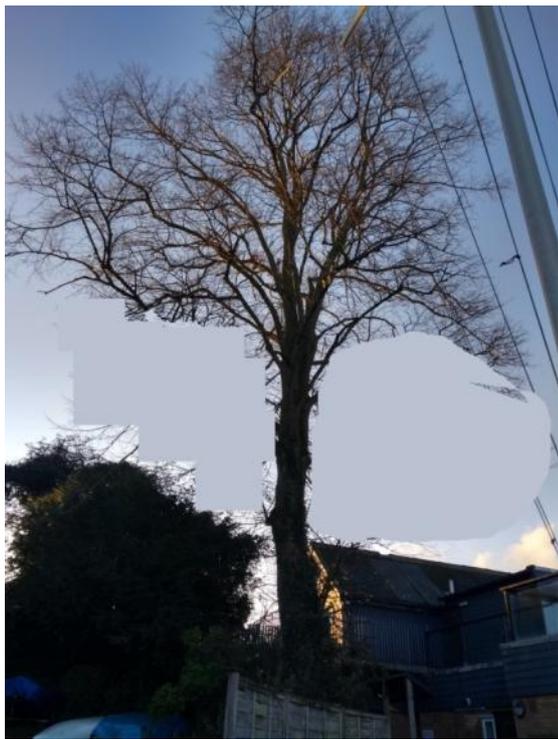
Lime tree with lower branches removed –

edited photo showing the proposal as it would look if this work were carried out, as seen from the public footpath in front of the sailing club and along the top of the beach. Further shortening of branches is also proposed.

The result of this operation would be seen from the river, and from the far bank, as it is the most prominent tree, and also from the footpath from the Church (View 1 above) which is at present a splendid view of the river. It would spoil the total effect of the tree groups between the arable land and the shore.

I would strongly oppose the proposal as I believe it is detrimental to the tree and to the landscape.

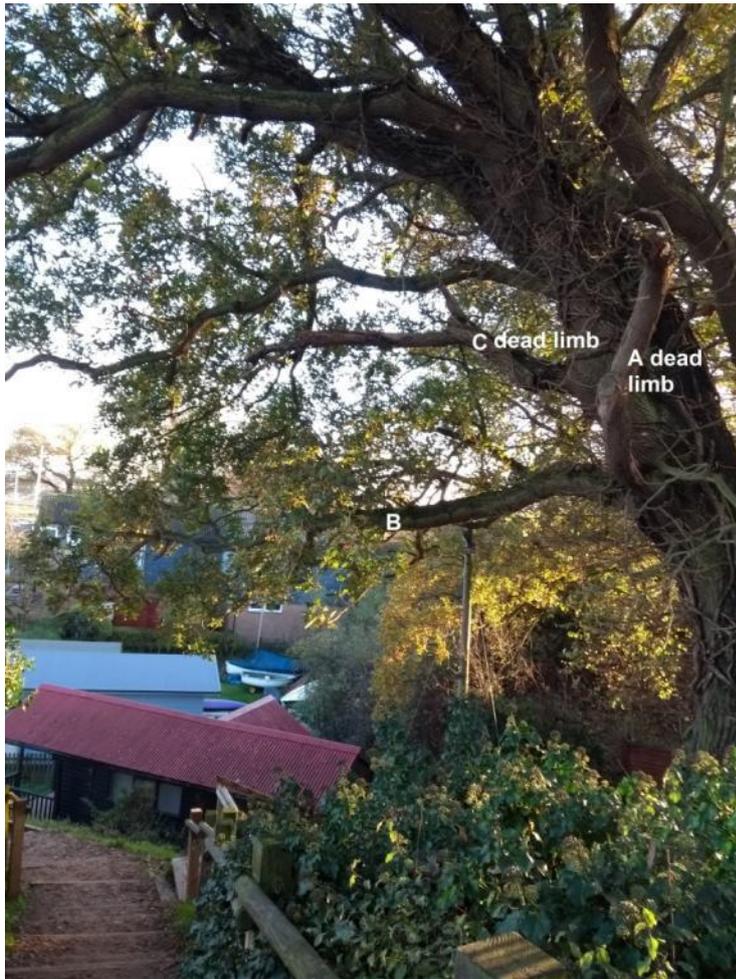
My photo (View 3) from the top of the steps with the foliage of the lower branches helping to screen the Sailing Club from view. Limbs A and C are dead . Limb B is healthy apart from a small amount of dead wood near the end of the branch.

This old veteran pollard may be one of the 300 year old oaks mentioned in the SCDC description above. It grows at the top of the wooden steps which lead down to the beach, up and down which many families have climbed over the years.

The tree has some dead wood which might be removed . The branches which are healthy with foliage on them frame the view coming down the steps. The hut below with red roof is some distance from the farthest extremity of the branches and the other shed fitted into the bank more recently is also beyond the canopy. I would propose that only dead wood is removed . However it should be noted that older oak trees usually have some dead wood on them which is beneficial to wildlife such as woodpeckers and insects. In this case the larger dead branches have been shortened by being chopped off at right angles in the past which poor practice may have led to their subsequent death by allowing in pathogens .

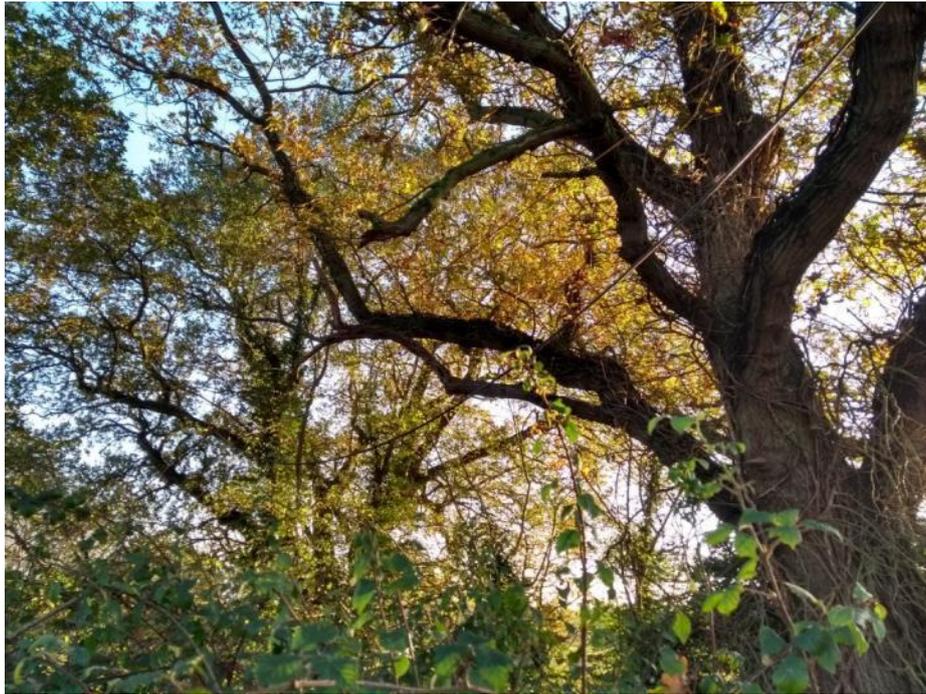
View 4 of the oak tree from small gate half way up the steps.

The other limb proposed for removal, limb D is largely healthy but carries some dead wood on one of its side branches.

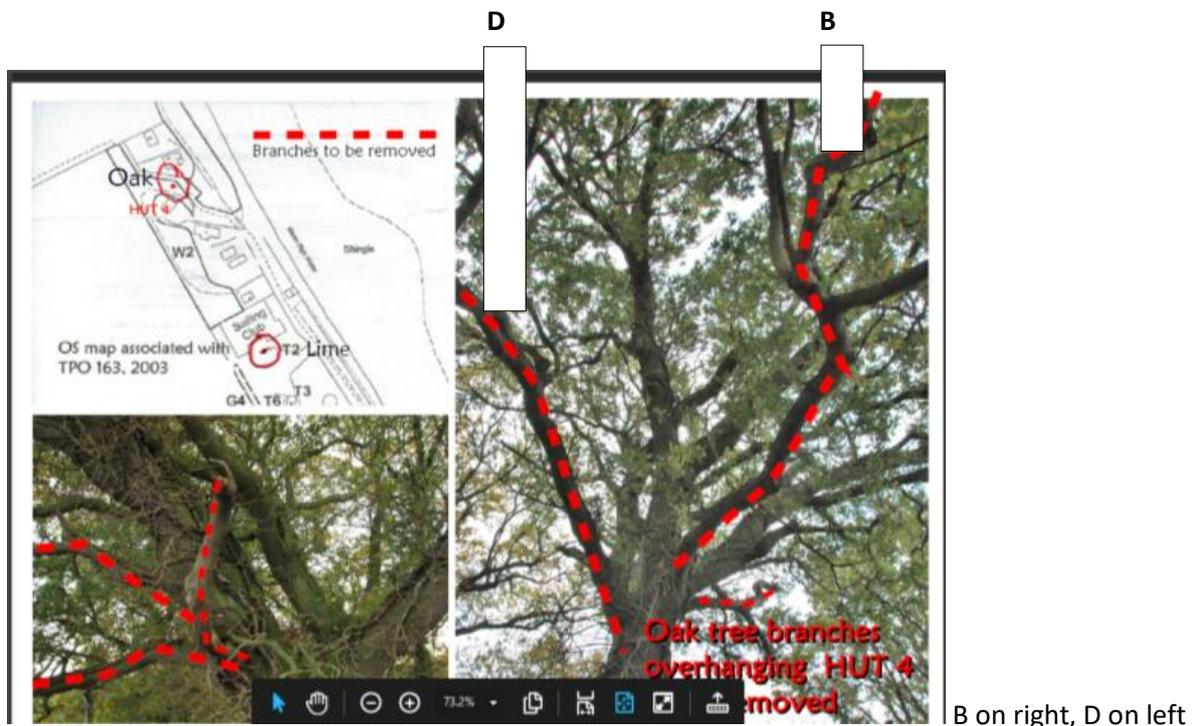
B on right, D on left

The applicants's submission. It is not altogether clear which branches are referred to. However having viewed the tree several times I think limb D is one which has a side branch off it with some minor dead wood at the end of it . I would submit that removal of dead wood is sufficient work on this venerable old tree.

The small amount of dead wood does not warrant removing largely healthy branches which frame the view with foliage, as one descends the steps.
